INVENTORY FORM FOR STATE HISTORIC SITES SURVEY

Fairgo

Cumberland Fairgrounds

Moss Avenue, Potomac Park

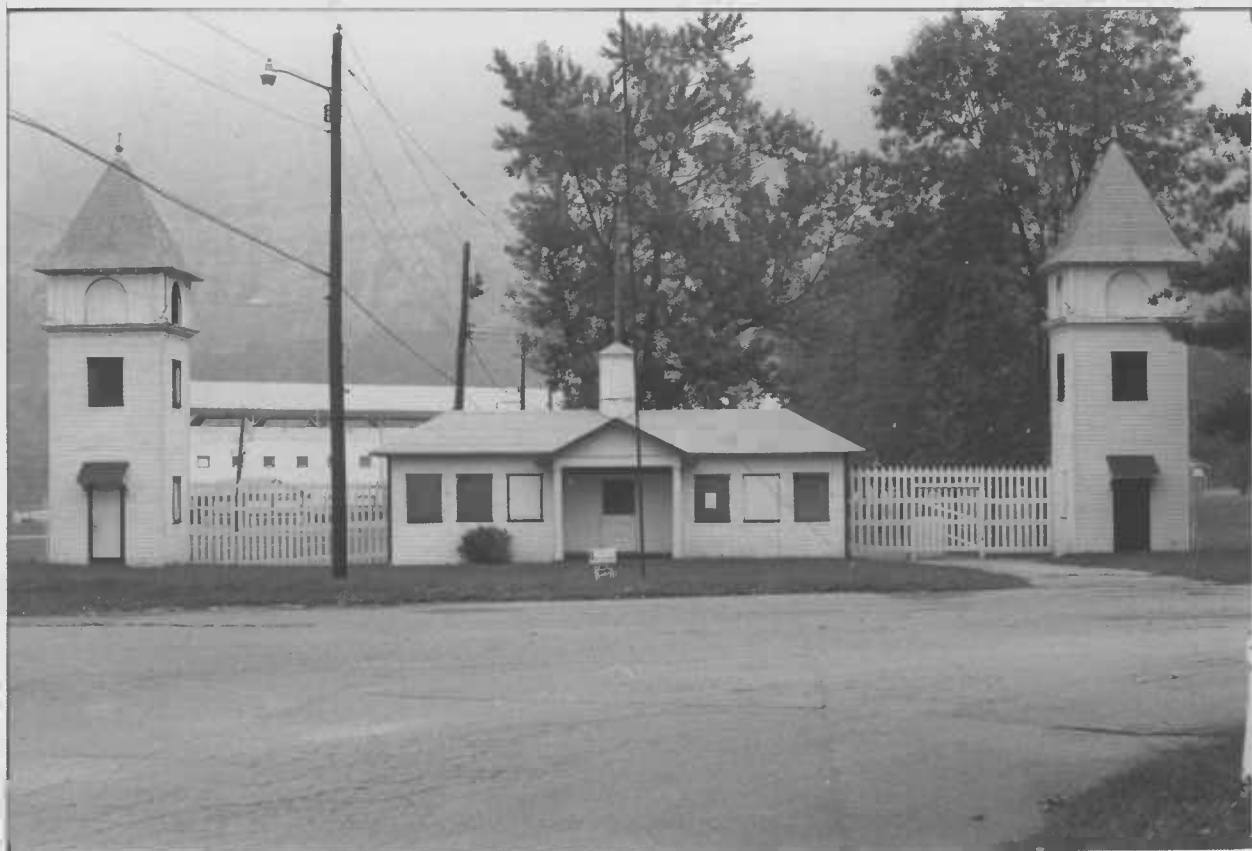
MAIN ENTRANCE

The main entrance to the fairgrounds is a gatehouse with wooden towers on either side. The one story, seven bays wide gatehouse is frame with german siding resting on a low cement foundation. The hipped gable flank roof, with eaves consisting of a fascia and rafter ends, has an octagonal copula with a peaked roof. Entrances and casement windows are pedimented. The main entrance in the center of the western facade is recessed with a columned gabled portico. Picket fences connect the identical towers to the gatehouse. The square three stage wooden towers are frame with german siding. Entrances have simple hoods and windows are pedimented. Semicircular openings on the third stage are boarded up. Capped pilasters in pairs are located in the corners of the third stage. Eaves consist of rafter ends. Peaked bellcast roofs with finials are covered with asphalt shingles.

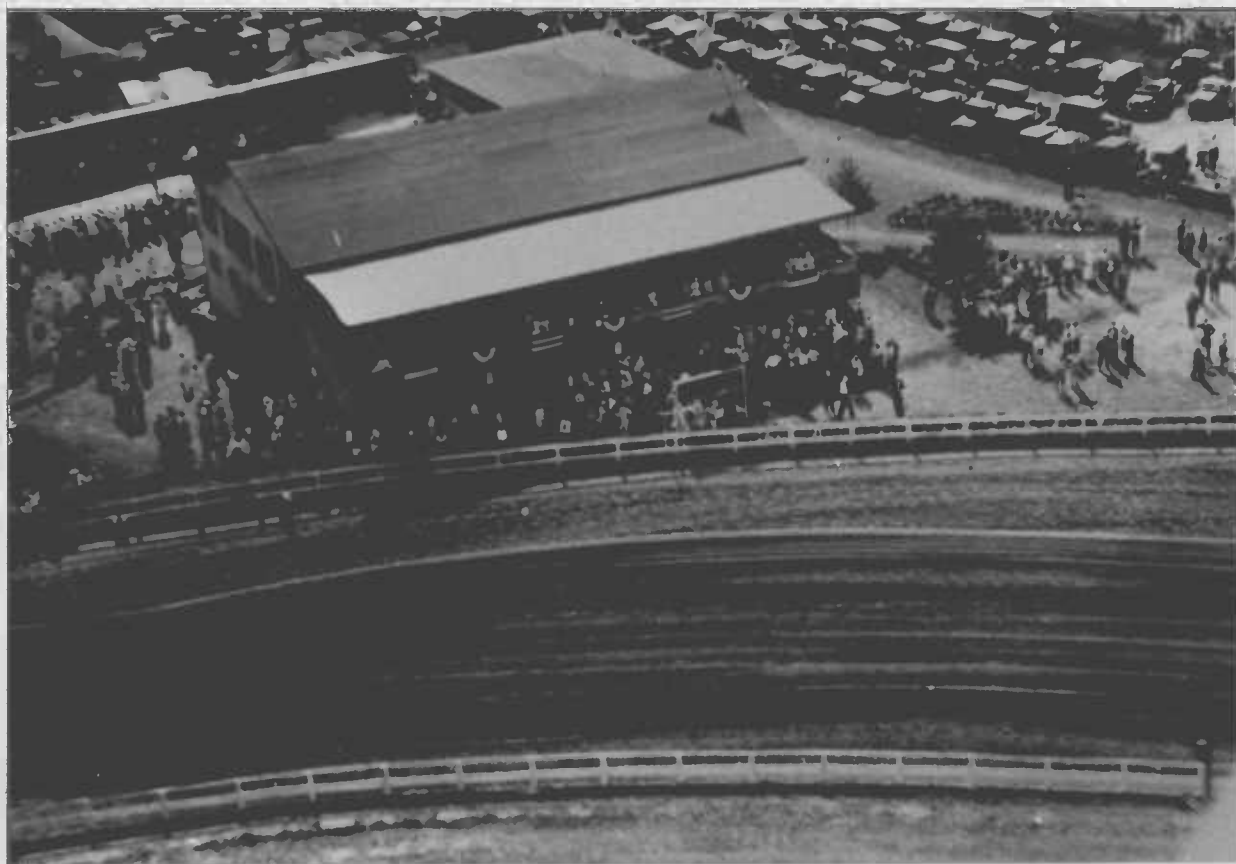
GRAND STAND

The grandstand is a long rectangular frame structure with german siding. The gabled roof is supported by bracketed wooden posts. Box seats are located in the center of the stands. A press box on the roof of the grandstand was added in the late 1930's.

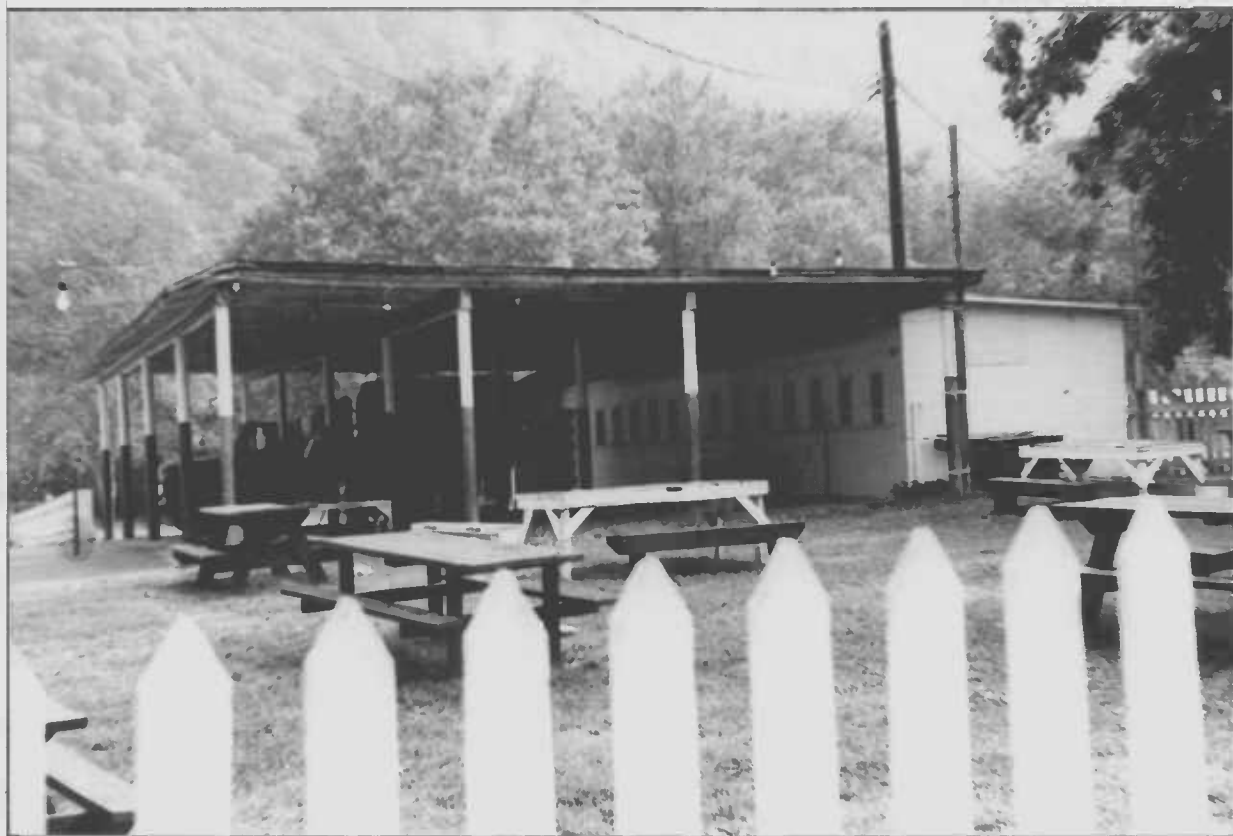
Cumberland Fairgrounds
Paddock

Most of the paddock has been removed. What remains is a small rectangular frame structure with a shed roof and a row of betting windows on the northeast. A large pavillion has been added to the northeast.

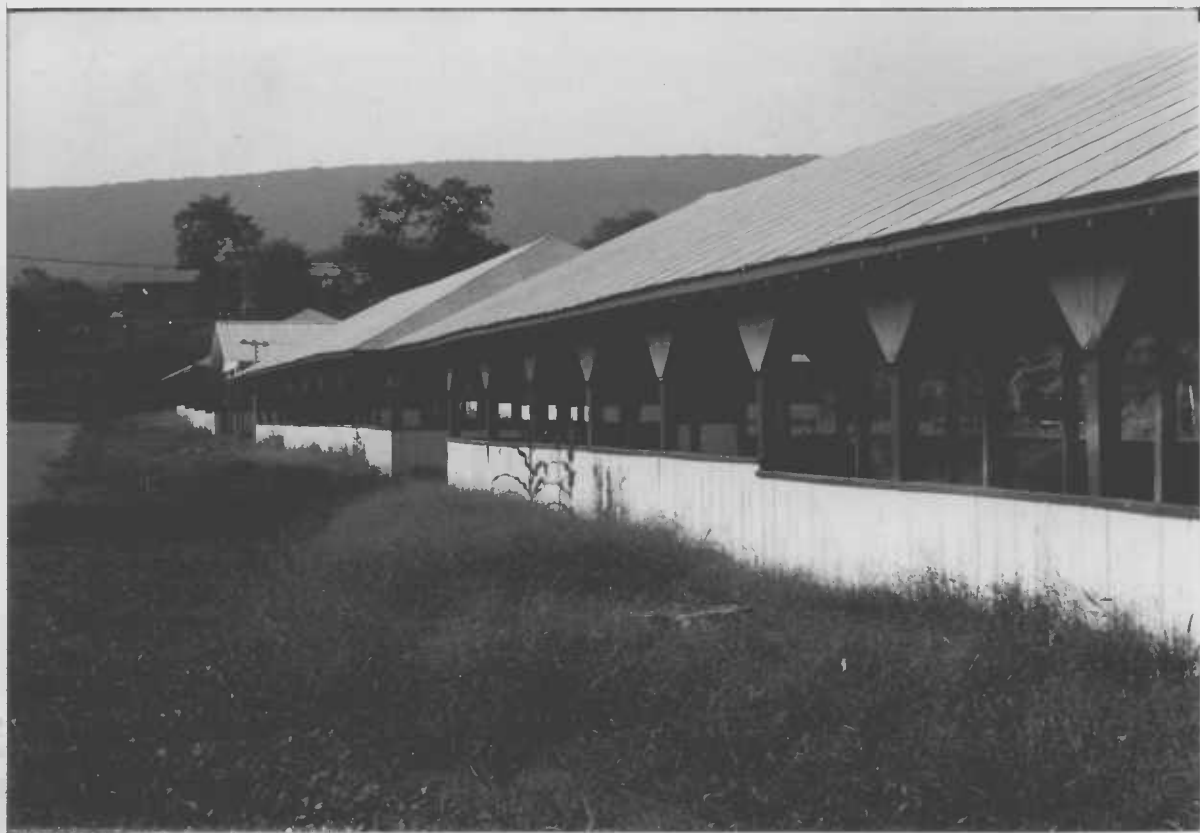
CUMBERLAND FAIRGROUNDS
BARN

A variety of exhibition halls, barns, and stables are located throughout the fairgrounds. One remaining stable for racing horses is a long rectangular structure of vertical planks with a gabled roof. The roof is extended on the northwest and supported by wooden posts. Two exhibition halls are rectangular frame buildings with german siding. Low hipped roofs have one story monitors with hipped gable roofs. Windows are six light casements. Double entrances have shed roofed porches. Five livestock barns are open pavillions with gabled roofs supported by bracketed posts.

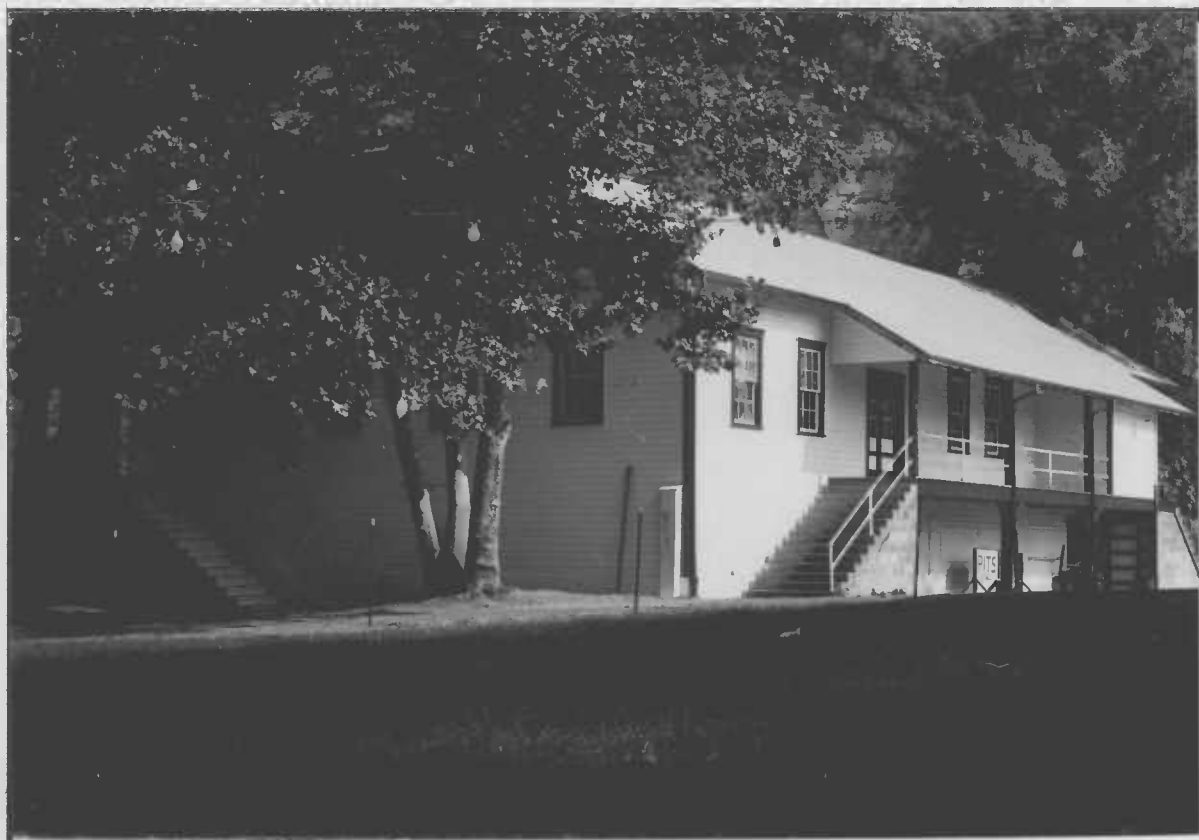
CLUBHOUSE

The clubhouse consists of a rectangular, two story, six bays wide frame structure with german siding resting on a low cement foundation. The gabled roof has been flatened. Eaves consist of rafter ends on the flanks and cornice and soffit on the ends. Movable panels on the northeast open the interior to a shed roofed porch on trackside. Pedimented six over six light sash windows have wooden lugsills.

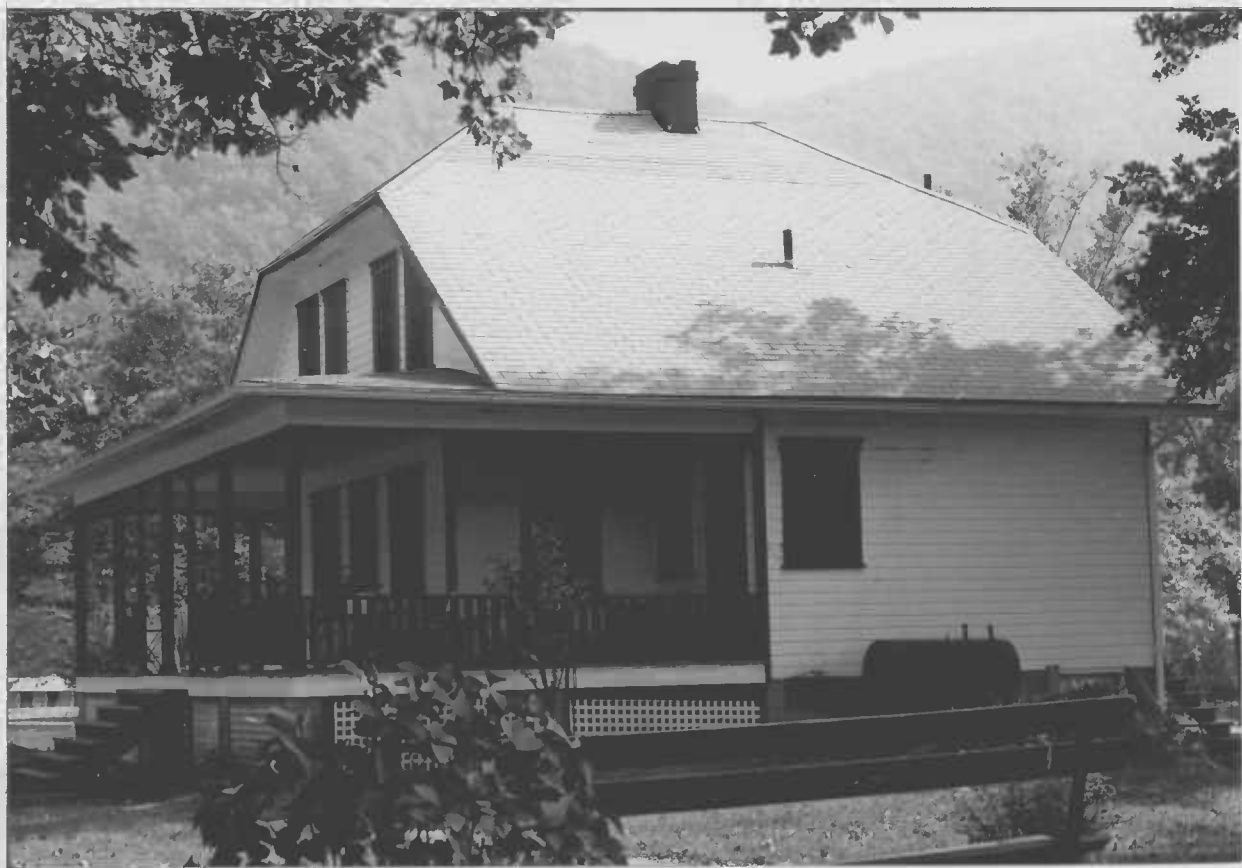
CUMBERLAND FAIRGROUNDS
GROUNDSKEEPERS HOUSE
MOSS AVENUE POTOMAC PARK
DAVID A. DORSEY

The Groundskeeper's Residence consists of a one and one-half story, seven bays wide, "T" shaped frame structure with german siding. It rests on a high cement block foundation with a plain water table. The steep hipped gable roof is covered with asphalt shingles. Eaves consist of a cornice, soffit, and frieze. Wall features include cornerboards. A brick chimney in the center of the building has a corbeled cap.

The pedimented main entrance, in the center of the northeastern facade, includes a two panel, four light door with original hardware. Two other pedimented entrances on the ends of the northeastern facade, are located on the recessed umbrage porch. Windows are nailed, pedimented six over one lights with wooden lugsills. Four pedimented windows on the first floor are wide eight over one lights with wooden lugsills. A porch on the northeast is umbrage on the southeast and northwest and has a hipped roof supported by square wooden posts. A shed roofed porch is on the southwest.

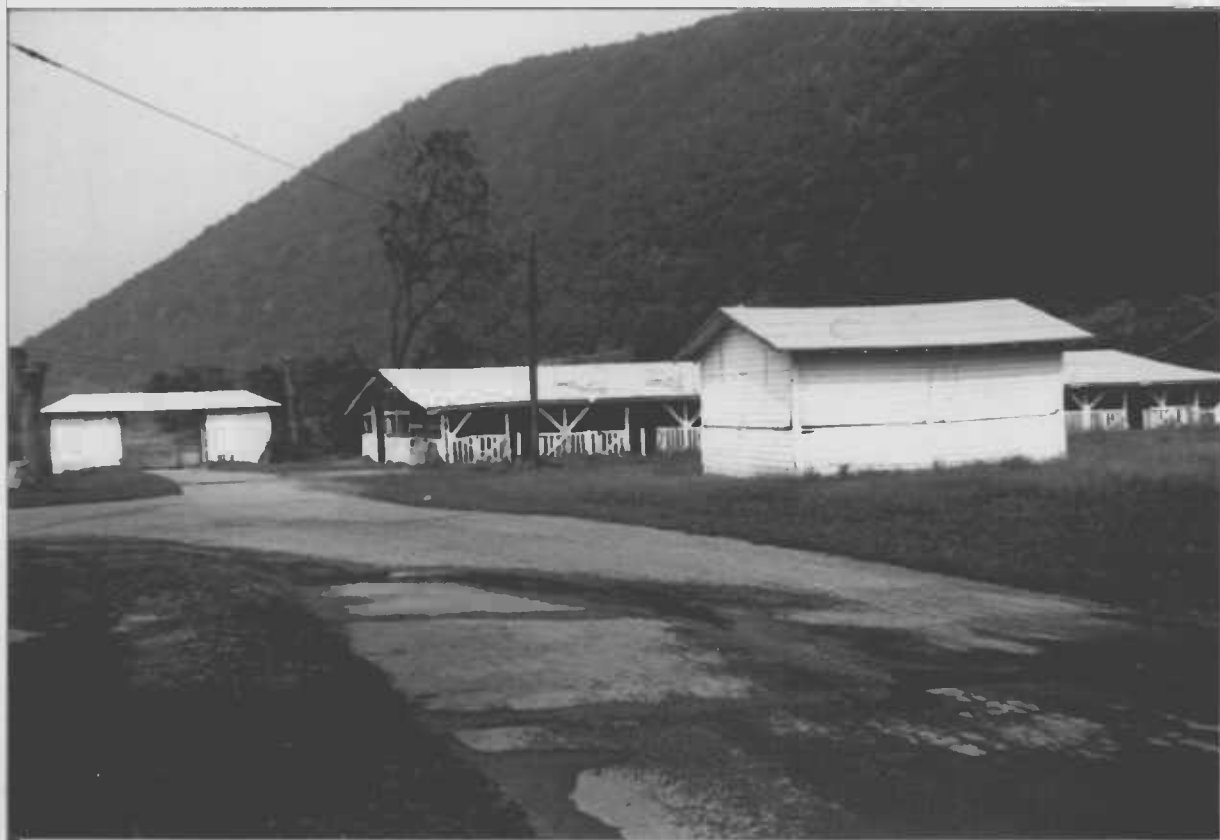
CUMBERLAND FAIRGROUNDS
N. ENTRANCE AND BARN
MOSS AVENUE POTOMAC PARK

A smaller entrance on the northern side of the fairgrounds consists of two square frame ticket booths which share a common hipped gable roof serving as an entrance.
